# Container Loading Inspection Report

Product description: Windows,fireplace,garage door

Loading location : Foshan city,Guangdong China

Factory: Foshan EMD doors and windows factory

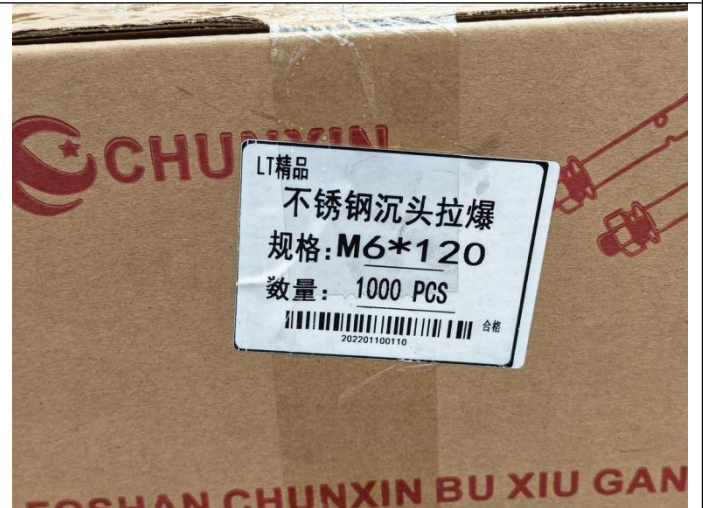
Shipping Mark

Shipping Marks (on 2 side):	Pending
Side Marks (on 2 side):	Pending
Inner Box Marks (on/side)	Pending
<b>Result:</b>	Pending
<b>Remark:</b>	No marking and label information provided, based on actual finding, pls see pictures.

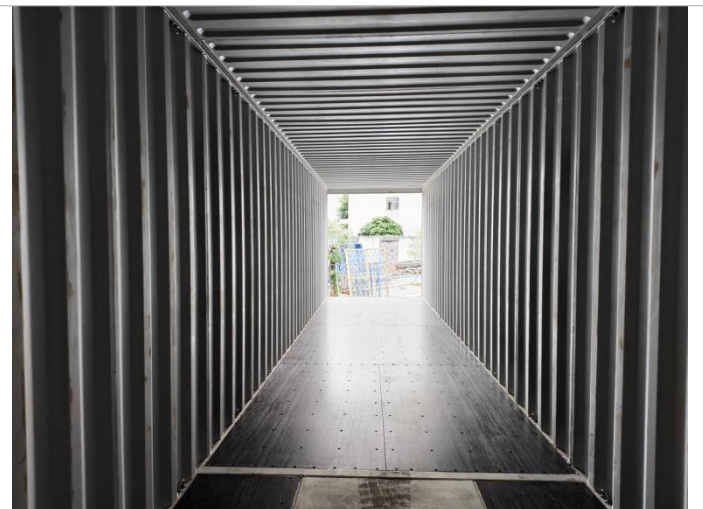
Light leakage check
