# INSPECTION REPORT

<b>Inspection Report No:</b>	MT-20260521-001	<b>Date:</b>	May 21th, 2026
<b>Inspection Notification No:</b>	01	<b>Date:</b>	May 14th, 2026
<b>PO No.:</b>	N/A	<b>Date:</b>	N/A
<b>Client:</b>	N/A		
<b>Material on Order:</b>	Aluminum hot mill work roll		
<b>Supplier:</b>	Wuxi Huake Special Steel Co., Ltd	<b>Location:</b>	<b>Wuxi City, Jiangsu Province</b>
<b>Sub-Supplier:</b>	N/A	<b>Location:</b>	N/A
<b>Visit Date (s):</b>	May 21th, 2026	<b>Inspection:</b>	STAGE / <b>FINAL</b>

PO ITEM No.	DESCRIPTION OF MATERIAL / EQUIPMENT	Tag / ID No. / S. No.	ORDERED QUANTITY	OFFERED QUANTITY	ACCEPTED QUANTITY
/	Aluminum hot mill work roll	005628-0101-R01	1	1	0

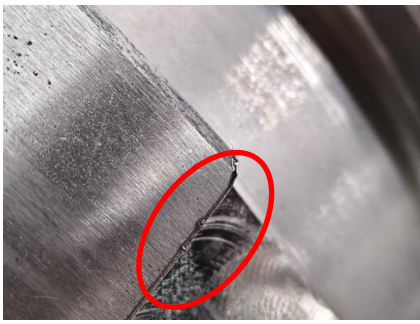
Pic.25 Visual inspection-Burr

- The inspector witnessed the visual inspection on site, found some burrs on surface. The result is unacceptable. The factory will fix this problem.
- The inspector witnessed the hardness test on site, the hardness of roll body were HS73.1-75.8 and surface hardness of roll neck were HS43.2-43.9, according to customer and drawing requirements(HS73-76 at roll body and roll neck HS42-45), the result is acceptable.

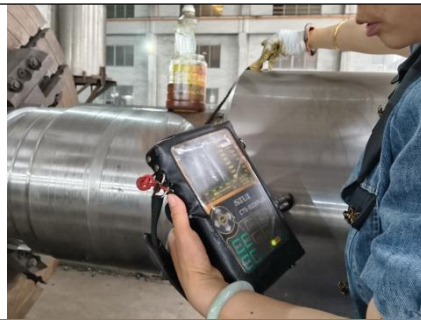
Pic.158 UT Test

- The inspector witnessed the Ultrasonic Flaw Detection(UT) for roll body on site,gain 64.0dB, step 6.0, sound path 1300.0mm, speed of sound 3230m/s, before the test, the surface of the equipment should be cleaned to remove paint, rust, oil stains and other contaminants. Then, a coupling agent should be evenly applied to the surface. The UT was conducted using an ultrasonic flaw detector. During the test, the a-scan waveform on the monitor was monitored and no abnormalities were observed. according to customer and drawing requirements, the result is acceptable.

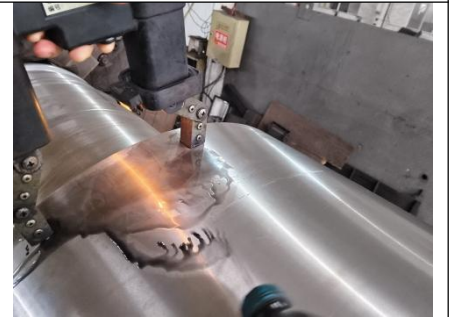
Pic.162 MT Test

- The inspector witnessed the Magnetic Particle Inspection(MT) for roll body on site,the test voltage 220V and current 3A, no cracks or other defects were found surface the product through testing, according to customer and drawing requirements, the result is acceptable.

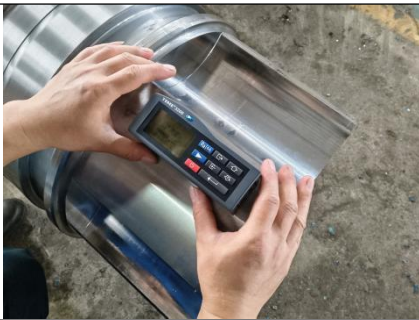
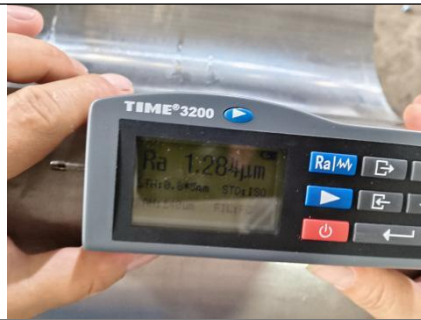
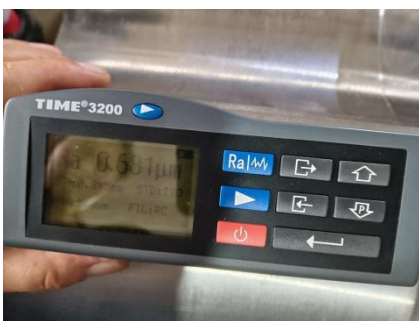
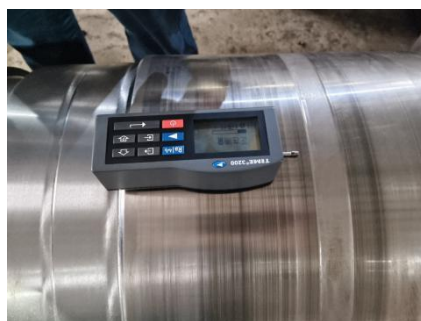
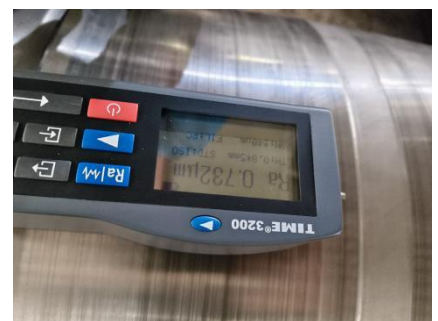
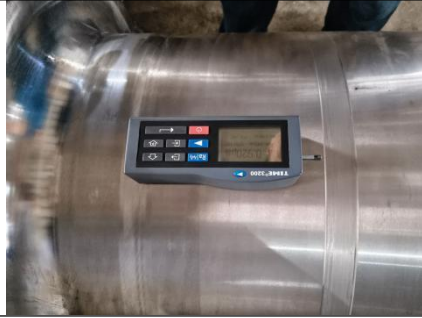
- The inspector witnessed the surface roughness inspection on site, **found the roughness of roll body is about 0.798-0.946um(the requirement is 0.4um)** and roughness of roll neck is 0.339-1.28um(the requirement is 0.8um/1.6um),**The result is unacceptable.**
